Orlando, Florida
April 24-27, 2005

TRENCHLESS REHABILITATION OF THE INDIAN ROCKS BEACH FORCE MAIN REPLACEMENT

William H. Gill, PE¹, and Dorian Modjeski, PE, DEE²

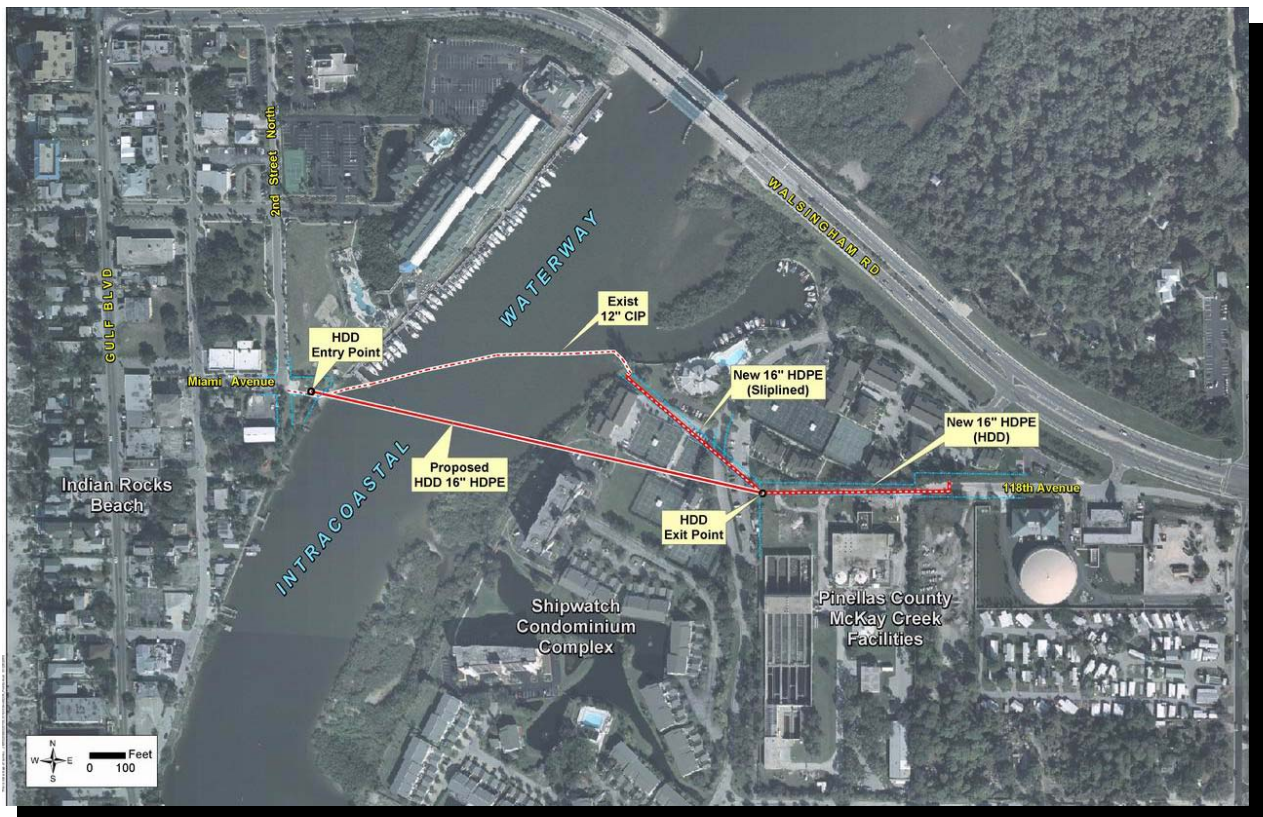
Figure 1

Several alternative pipeline alignments for the proposed HDD crossing were considered and evaluated. In general, the alignments followed the existing pipeline with the drilling and pull-back operations being positioned on either side of the Intracoastal Waterway. The recommended alignment, which did not follow the existing pipeline, has the drilling and pull-back operations located on the west side of the Intracoastal Waterway and the pipeline layout and fabrication site on the County's McKay Creek property. See Figure 1.

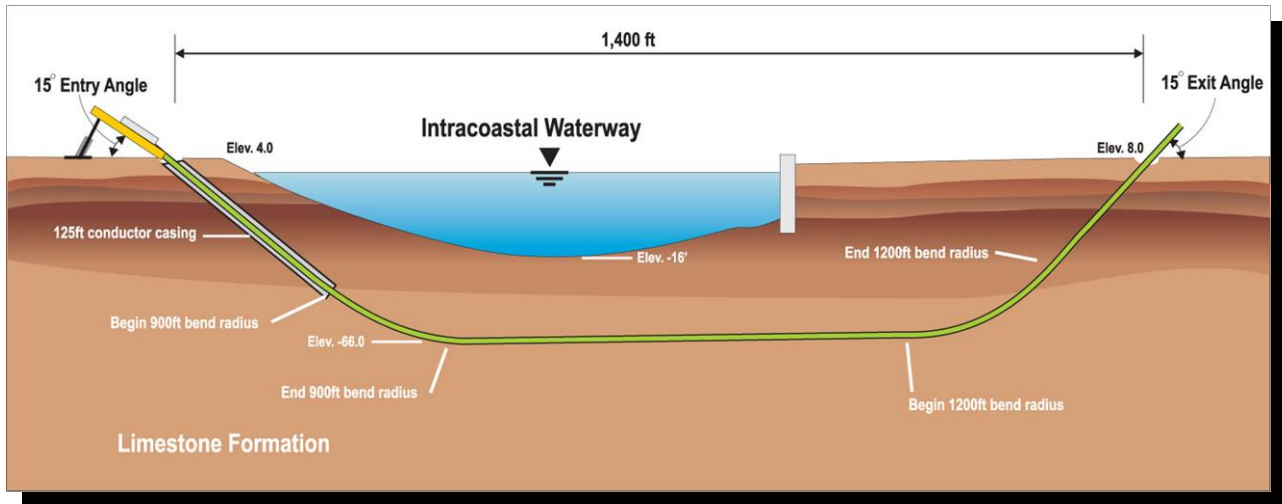
Figure 2

Alternative profiles were evaluated by TBE Group during pipe design. The final profile is shown in Figure 2.

The final profile was chosen based on the feasible entry and exit angles, establishing the depth to keep the majority of the steering operations in reasonably uniform soils, and maintaining the original entry and exit points.
