Orlando, Florida
April 24-27, 2005

TRENCHLESS REHABILITATION OF THE INDIAN ROCKS BEACH FORCE MAIN REPLACEMENT

William H. Gill, PE¹, and Dorian Modjeski, PE, DEE²

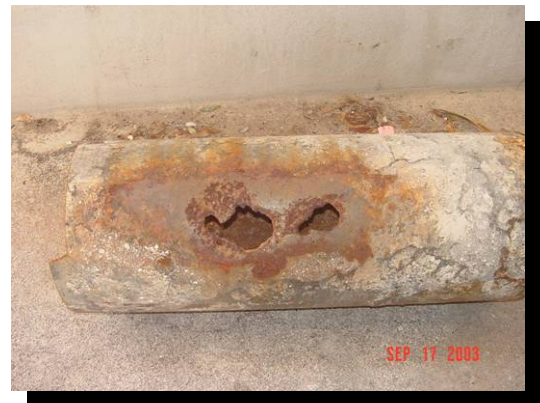
Over the last ten years, and more recently, the force main has experienced a number of breaks, most often occurring on the easterly side of the Intracoastal Waterway in the Shipwatch Condominium Complex and the McKay Creek Wastewater Treatment Plant (WWTP) site. Probable causes of pipeline failures are due to corrosive soils, possible stray electric currents, and hydraulic surges in the pipeline.

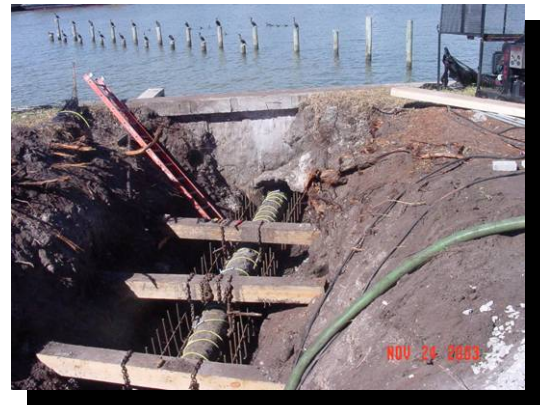
Once the new HDPE pipe sections were constructed and tested, connections to the existing force main took place. At the downstream end, the connection was made to a relatively new section of polyvinylchloride (PVC) pipe using a pressure tap fitting and valve including a line stop. At the sea wall location, the connection was made by a wet tie-in to the existing cast iron pipeline. The cast iron pipe was found to be severely encrusted with marine growth and its overall integrity questioned raising concerns over risk of imminent rupture. A special reinforced concrete encasement was designed and constructed to accomplish the connection. The pipe was initially excavated to the spring line. The pipe was then hand excavated in short segments and was supported from overhead cross beams spanning the trench. At the hanger locations, wood blocking was used to avoid point hanger loads on the pipe. The work was scheduled during periods of low flow between midnight and 5:00 AM. During this time, the pump station was shut down and vacor trucks were used to assist with the draining of the 12-inch cast iron force main and to provide emergency back-up at the pump station, if necessary.

Due to the poor foundation conditions the concrete encasement was supported on screw piles. To improve the water tightness of the encasement in the event a leak developed, the pipe was wrapped with perforated PVC tubing that would permit the injection at the pipe/concrete interface with a hydrophilic compound to stop potential leaks.
